## WOOD DESTROYING PESTS AND ORGANISMS INSPECTION REPORT

Building No. 43569	Street Ellsworth Avenue	City Fremont	Zip 94539	Date of Inspection 6/10/2008	Number of Pages 5
<b>Prime Exterminators of Northern California Inc.</b> <b>1752 Angela Street</b> <b>San Jose, CA 95125</b> <b>(408) 275-0364 (800) 820-BUGS Fax (408) 275-0365</b>			<b>* Integrity</b> <b>* Professionalism</b> <b>* Reliability</b>		
Registration# PR 3506			Record # 10770		
Ordered By: <u>41111 Mission Blvd. Fremont, Ca. 94539</u> <u>(510) 580-8262 Legacy Real Estate &amp; Associates JP Mobasher</u>		Property Owner and / or Party of Interest: <u>c/o agent</u>		Report Sent To: <u>Legacy Real Estate &amp; Associates JP Mobasher 41111 Mission Blvd. Fremont, Ca. 94539 (510) 580-8262</u>	
COMPLETE REPORT <input type="checkbox"/>			LIMITED REPORT <input checked="" type="checkbox"/>		
General Description: <u>1 Story siding and frame Residence Vacant and Unoccupied with a Composition Roof and Detached Garage on Unimproved Underarea</u>			REINSPECTION REPORT <input type="checkbox"/>

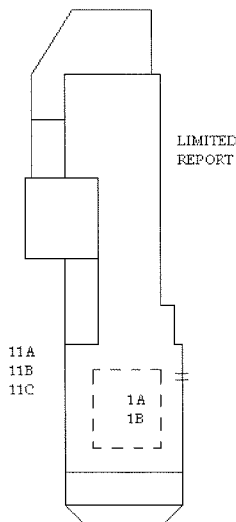
Finding: 1A Evidence of subterranean termites noted in throughout the subarea as indicated on the diagram.

Finding: 11A Evidence of drywood termites extending into inaccessible areas noted in various areas of exterior as indicated on the diagram.

Finding: 11B Evidence of drywood termite damage noted in various areas of exterior as indicated on the diagram.

Finding: 11C Evidence of fungus damage or dryrot noted in various areas of exterior as indicated on the diagram.  
Recommendation: We recommend owner contact licensed contractor(s) to make necessary repairs and corrections, per local building code requirements.

Finding: 1B Area(s) was not inspected and is noted in subarea as indicated on the diagram.  
Recommendation: a visual inspection from the basement entry was performed. A general contractor and engineer should be consulted regarding numerous problems.

Recommendation: Chemically treat the soil at probable termite entry points of the property with Premise 75 (Imidacloprid) or Termidor SC (Fipronil) for the control of Subterranean Termites. In conventional construction, this may include, but is not limited to, rodding or trenching the soil around the foundation walls, piers, and plumbing pipes in the subarea; rod-ding or trenching the soil around the exterior foundation; drilling attached slabs (or black-tops) such as patios, porches, sidewalks or driveways that abut the structure; drilling brick or stone veneer that extends below grade level; treating voids in the foundation walls or piers. Remove the termite shelter tubes (if present) from the accessible areas. Prime Exterminators will not be liable for possible damage to hidden pipes, conduits or ducts in/or under concrete slab.  
this should only be done after all earth to wood contacts, faulty grades and cellulose materials on soil are corrected.

Recommendation: Due to the nature of these infestations, it will be necessary to seal the entire structure and fumigate it with Vikane (Sulfuryl Fluoride), using Chloropicrin as a warning agent. The entire structure must be vacant for up to 72 hours for this process. We will shut off utilities to this structure prior to fumigation; however, it will be the owners' responsibility to contact P G & E to have the utilities turned back on when the fumigation is complete. We will use all due caution in our operation; however, we assume no liability for any damage to the roof covering, solar panels, TV antenna or plantings adjacent to the structure. The occupants must sign the Occupant's Fumigation Notice and comply with all of the instructions. The warranty for the fumigation is THREE YEARS from the date it is completed.

Recommendation: We recommend owner contact licensed contractor(s) to make necessary repairs and corrections, per local building code requirements.
